Township of Denville 2019 Walkability Assessment Report

2019 Walkability Assessment Report

TransOptions, Inc.

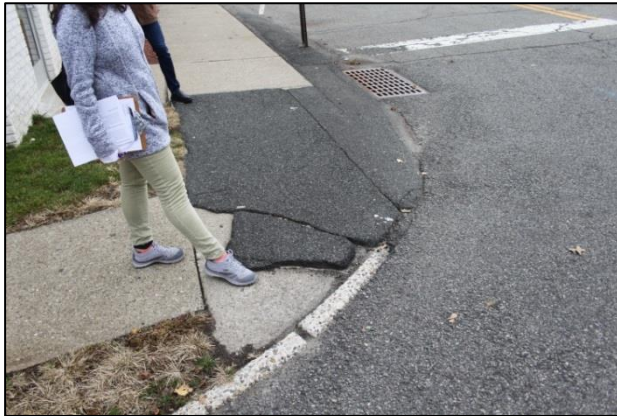
In addition to unmarked crossings, many of the non-signalized crossings lack signage and truncated domes. Specifically, Myers Avenue intersection lacks truncated domes and is covered in asphalt making the corner uneven and a tripping hazard.

Crossing at Myers Avenue

- Install high visibility crosswalks at key intersections to be consistent throughout the Township (see Appendix A)
- Install truncated domes at all street crossings and makes sure all crossings are ADA compliant
- Install pedestrian crossing signage where missing at non-signalized crossings

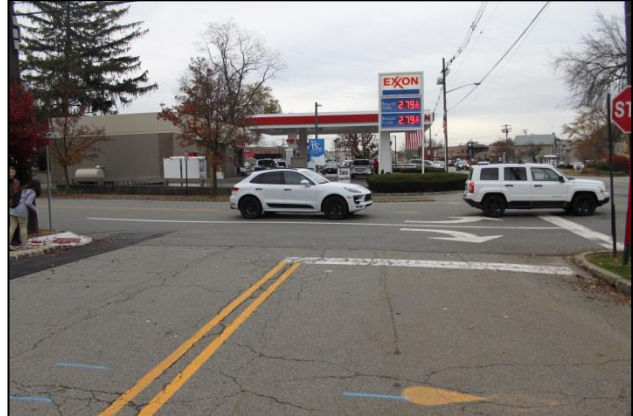
- Righter Avenue and Hinchman Avenue intersection- There is a lack of crosswalks and this crossing is also not aligned with the corner. The corner crosses several feet in from the corner creating a blind area

Crossing Hinchman Avenue and Righter Avenue

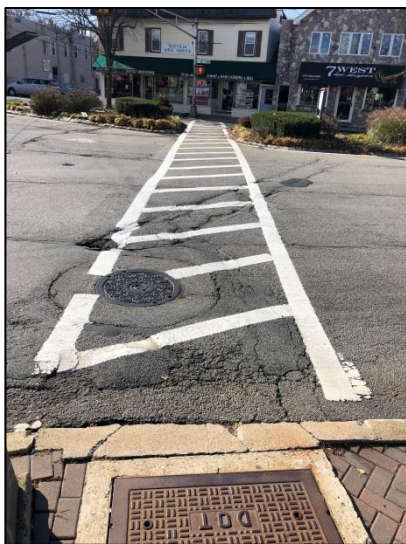
The crossing at West Main Street at Broadway and East Main Street has a faded crosswalk and lacking truncated domes. Along the West Main Street side of the crossing, a NJDOT utility plate is at the beginning of the crosswalk where a truncated dome should be located. Although this crossing is long, there is a pedestrian refuge median to break up part of the crossing.

Crossing West Main Street at East Main Street.

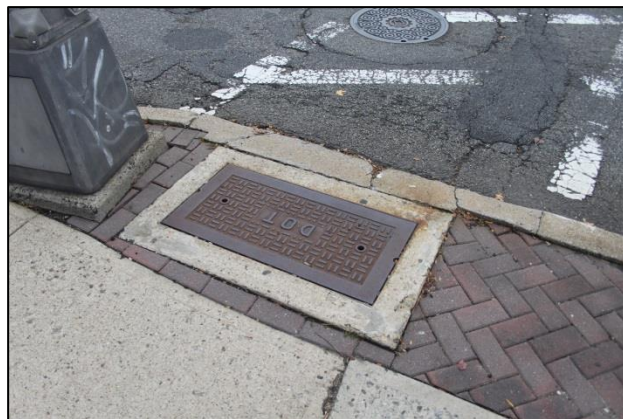
DOT utility plate where a truncated dome should be

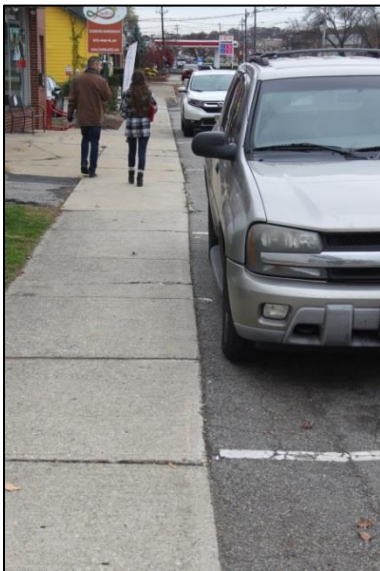
From St. Marys Place to Myers Avenue the sidewalks are not continuous mainly through the St. Mary's parking lot. Along Righter Avenue, the sidewalk is flush with road and street parking and there is no curb to separate the sidewalk from the roadway. Although the sidewalk and road are flush drivers did a good job not parking onto the sidewalk.

Sidewalk flush to roadway

- Continue sidewalk network throughout West Main Street and Righter Avenue
- Create ADA access for West Main Street municipal lot and bus stop
- Install curbing and road buffers between roadway and sidewalks

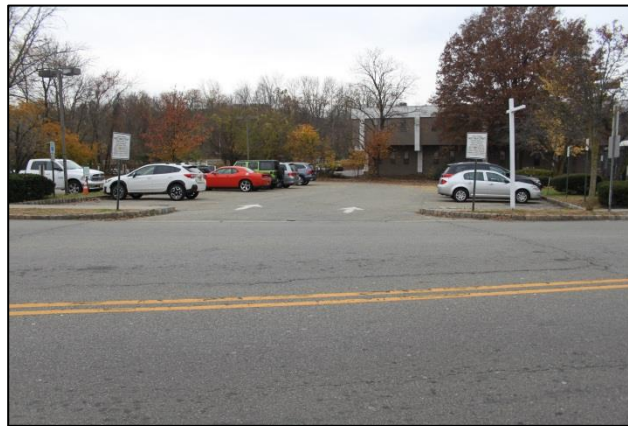
The West Main Street municipal parking lot provides access to the downtown and bus stops, however, curb cuts and truncated domes are missing on the sidewalk. Both bus stops along West Main Street have bus shelters, are off the sidewalk, and have pedestrian amenities which should be utilized as a good example for bus stops throughout the Township.

West Main Street municipal parking lot

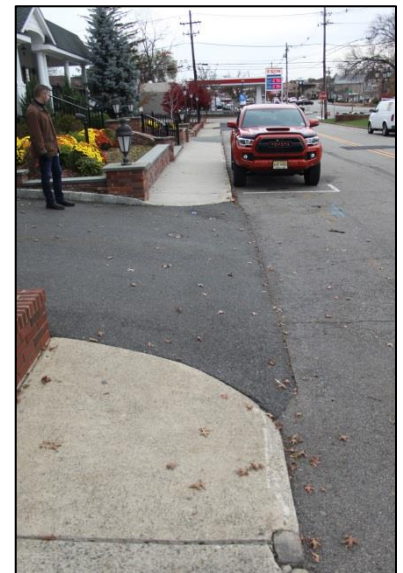
Sidewalk does not continue across driveways

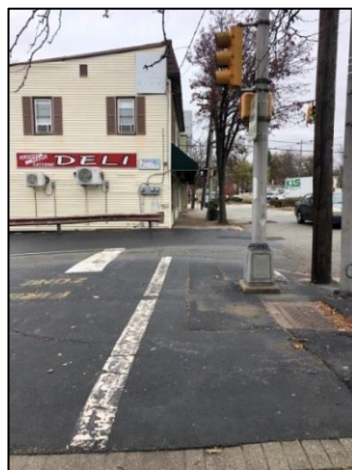
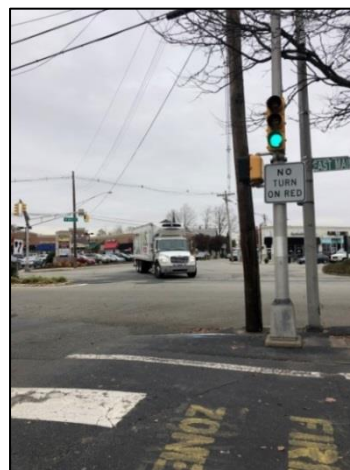
The parking lot driveway between 1 West Main Street (deli) and 1 East Main Street (cleaners) is signalized and has a pedestrian crossing signal along the sidewalk; however, crossing this driveway can be confusing, and the crosswalk that crosses the driveway is barely visible.

Signalized crossing and crosswalk at 1 West Main Street

- Create a high visibility crossing across the parking lot driveway between 1 West Main Street and 1 East Main Street where there is a pedestrian crossing sign. Signage and high visibility striping to let pedestrians know this area is controlled by the light. Truncated domes are also needed at this crossing.
- Make sure intersections are ADA compliant- East Main Street and Broadway Avenue intersection

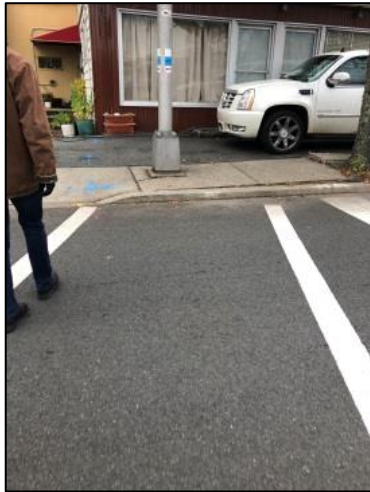
An additional area of concern is the crossing at East Main Street and Bloomfield Avenue. This crosswalk is low-visibility, truncated domes are lacking at both sides of the crossing, and the East Main Street side of this crosswalk has no curb cut and is blocked but the traffic signal pole.

Crossing at East Main Street
and Bloomfield Avenue

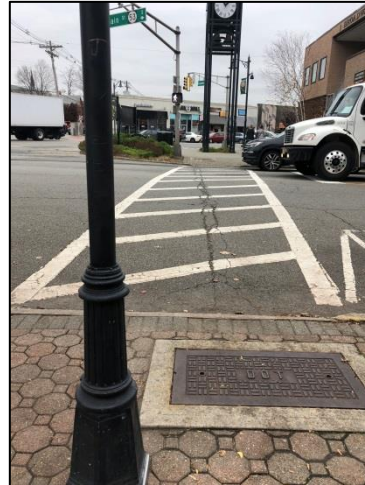
The intersection of East Main Street and Broadway is high visibility but there are no truncated domes at the crossing. Instead there are NJDOT utility plates.

Crossing at East Main
Street and Broadway

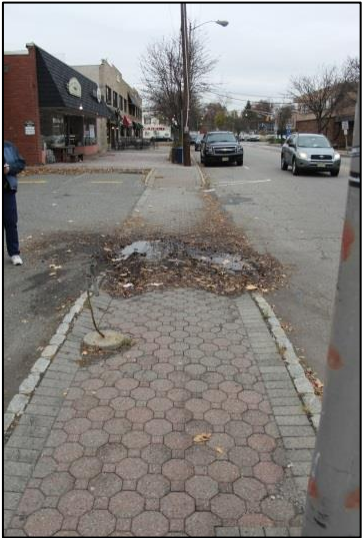
Cracked pavers and water retention along East Main Street

- Continue sidewalk across driveways
- Maintain sidewalk and make sure trees and signage are placed outside of the pedestrian zone
- Create a curb or buffer between parking lots and the sidewalk as well as between the sidewalk and the roadway
- Consider installing green infrastructure in areas that retain water

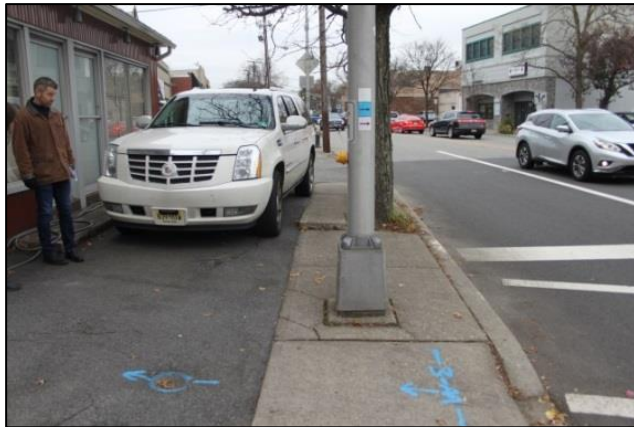
Traffic signal block that sidewalk and crosswalk at East Main Street and Bloomfield Avenue

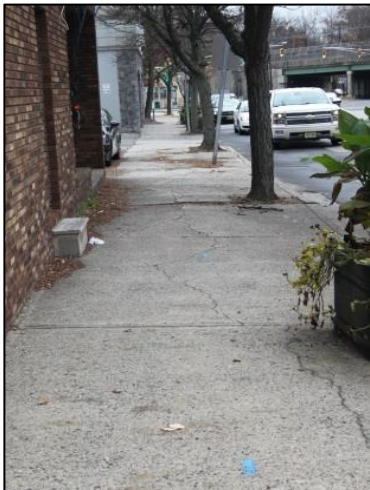
On the north side of the road going towards downtown, the main barriers for walkability are the condition of the sidewalks and a lack of a buffer between the sidewalk and parking lot. The parking lot next to 18 East Main Street is flush to the sidewalk and lacking a curb or buffer to keep the cars out of the sidewalk. Additionally, along this side of the road the sidewalk slopes in areas and is in need of general maintenance where pavers are uplifted or cracked.

North side of the road is wide but is in needs of maintenance

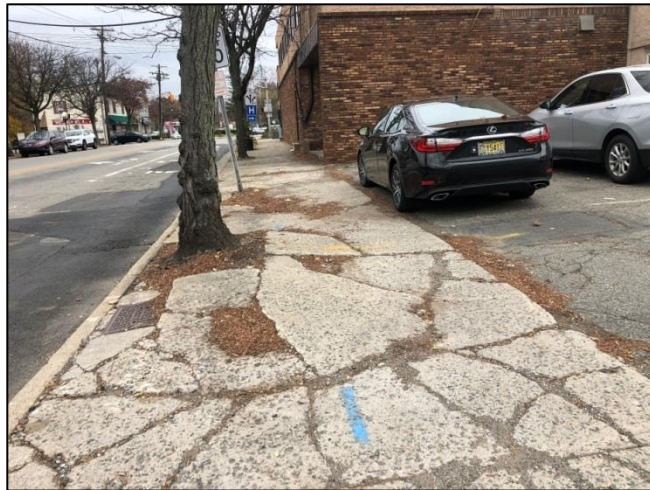
Cracked sidewalk on the north side of the road and a lack of buffer between the parking lot and sidewalks

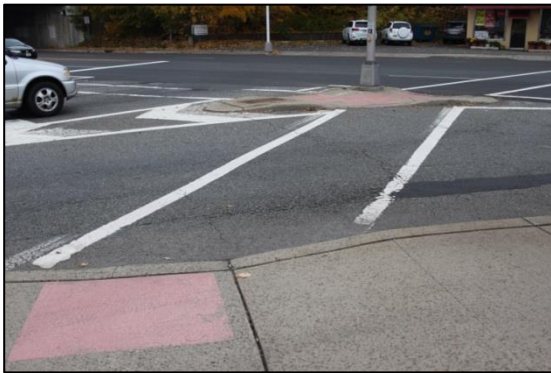
The main concerns in this section are the low visibility of crossings and missing ADA infrastructure. At the East Main Street and Bloomfield Avenue signalized intersection, the crosswalks are low visibility and a red painted square is in place of truncated domes. This intersection does however have a pedestrian crossing signal. Truncated domes are also missing at the intersection of Broadway and Bloomfield Avenue on the Bloomfield Avenue side. Aside from the missing ADA infrastructure, the crosswalk is high visibility with state law pedestrian crossing signage in the roadway. The crosswalk at the Route 46 ramp and Bloomfield Avenue is also high visibility with ADA infrastructure. This crosswalk is a good example to be used in other areas of the Township.

Crossing at Bloomfield Avenue to median

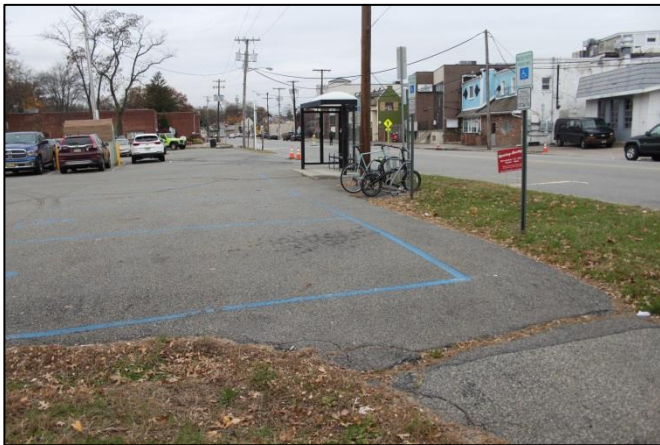
The main problems are located on the west side of the road. At the Bloomfield municipal lot and farmers market, there is an asphalt path leading to the parking lot where it ends. Within the parking lot is a bus stop. Since this area will eventually be repaved by the town, putting in a sidewalk along this section of Bloomfield Avenue that continues throughout the edge of the parking lot will provide a safer area for pedestrians.

Sidewalk ends at Bloomfield municipal lot

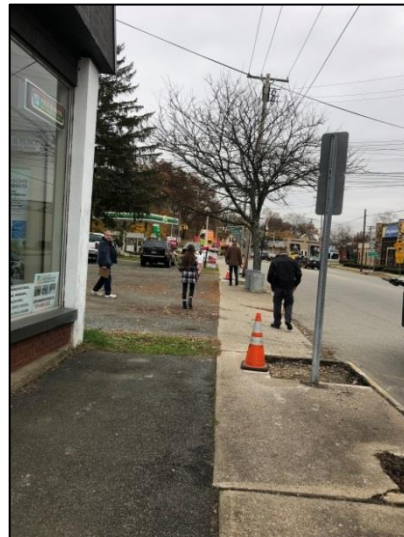
Sidewalk on west side of Bloomfield Avenue

Additionally, the sidewalk on the west side of the street is severely cracked, uplifted, and has signs and trees placed in the middle, blocking the path. The sidewalk also does not continue across the driveway entrance at 17 and 21 Bloomfield Avenue.

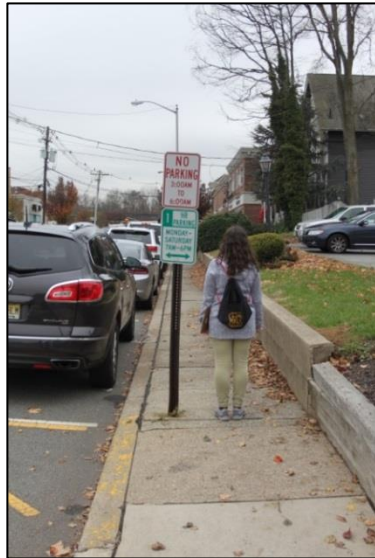
This section of Diamond Spring Road has a continuous sidewalk network with shops, outdoor seating, and pedestrian amenities. Some maintenance is needed along the sidewalk network including bushes trimmed out of the pedestrian zone by GNC, cracked drainage in the sidewalk, curb needs to be fixed at number 23, and parking signage hangs low over the sidewalk.

Low signage

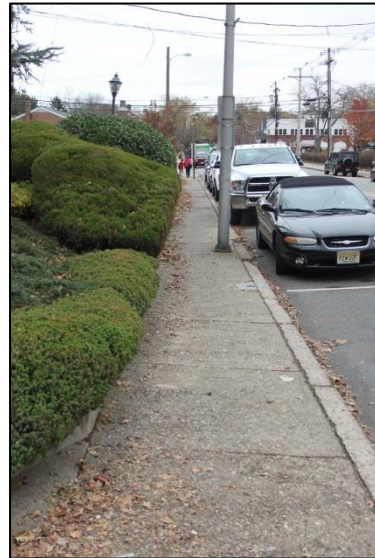
Sidewalk narrowed by post and bushes

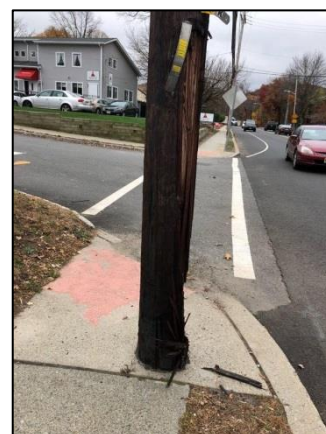
At the intersection of Route 53N and Cooks Road, a chipped pole with sharp wood sticking out blocks the sidewalk and creates an area of concern for pedestrians.

Chipped pole at Cooks Road

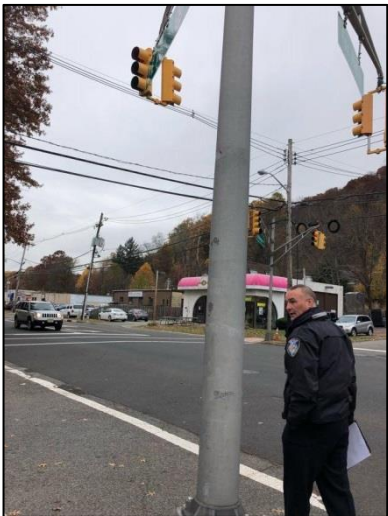
Fox Hill Road lacks pedestrian push button and walk signal

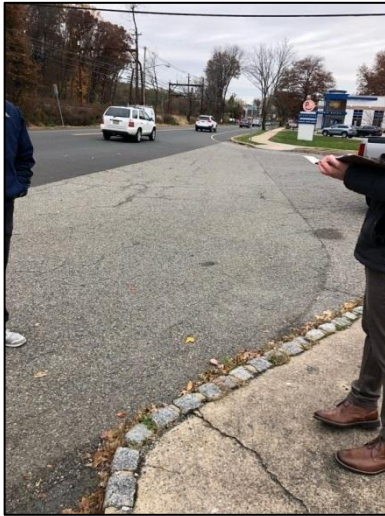
Manor Road crossing is wide, lacks crosswalk, and ADA compliance

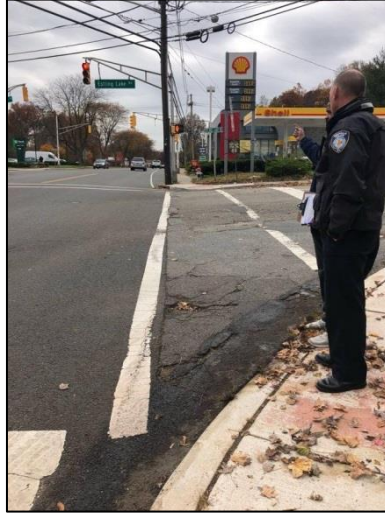
The Estling Road and Route 53 intersection and the Lugar Road and Route 53 intersection both feed you into the roadway because the curb ramp is angled into the intersection instead of directed towards the crosswalk. There is also no shoulder to act as a buffer between pedestrians waiting to cross and turning vehicle traffic.

Estling Road crossing lacks a buffer for pedestrian at corner

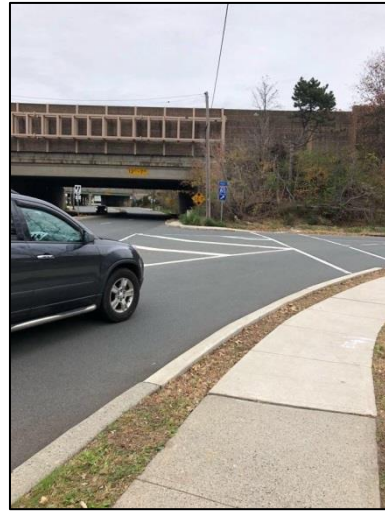
In addition to missing crosswalks, the crosswalk across the Route 80 east ramp is pushed back from the road and is difficult to see. Drivers don't seem to expect this crosswalk when entering the ramp and pedestrians find it hard to see drivers while crossing. Moving the crosswalk off the ramp or adding visible signage to alert drivers of the crossing can mitigate this issue.

Route 80 ramp crossing is low visibility

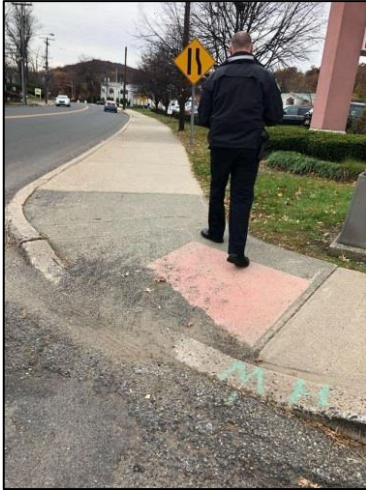
Throughout Route 53, the majority of the curbs have red rectangles painted onto the curb ramp to act as truncated domes but do not provide any tactical warning. This makes it difficult for pedestrians with vision impairments to detect a curb and is not ADA compliant. Some examples of non-compliant intersections are Fox Hill Road and Route 53 North as well as Bloomfield Avenue and Route 53 North. Additionally, the curb at the intersection of Route 53 and Estling Lake Road has a truncated dome, but does not lead to a sidewalk and does not provide a continuous route. Additionally, many curbs at business driveways lack curb cuts.

Curb ramp is painted no a truncated dome, is covered by debris, and a steep slope

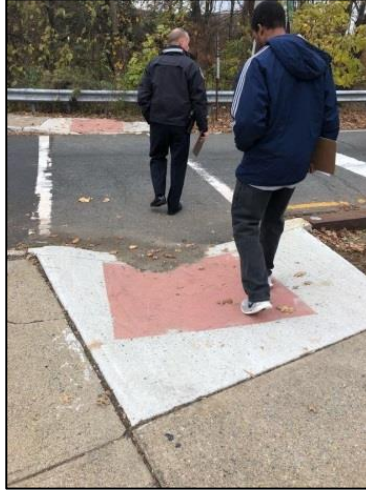
Curb ramp is painted not a truncated dome

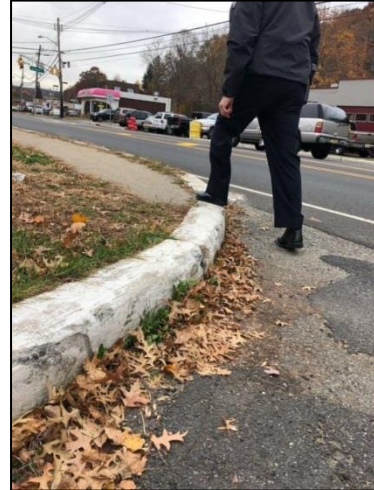
Lack of ADA compliance with no curb ramp or truncated dome

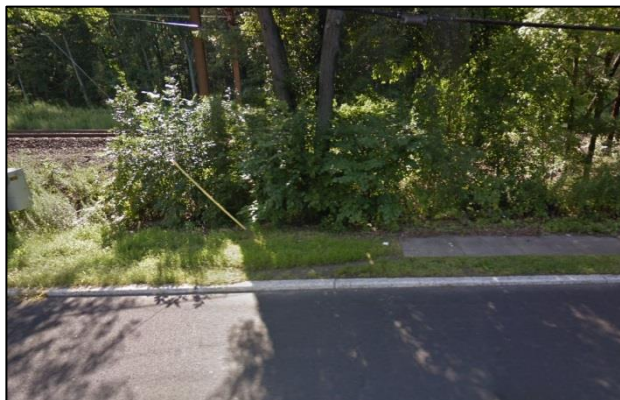
The sidewalk network along Route 53 provides connections to places of interest such as the Denville and Mount Tabor train stations, businesses, and the Morris County School of Technology, but is not continuous and is in need of maintenance in some locations. Sidewalks are more prevalent along the north side of the road. Sidewalks are lacking on Route 53 South from the Mile 4 marker to Dickerson Road/Station Road where the sidewalk abruptly ends between Estling Lake Road and Fox Hill Road. This lacking infrastructure limits access to several bus stops along Rt. 53 making people wait in the grass or roadway. This also limits access to stores and the Mount Tabor Train Station from this side of the road.

Sidewalk ends on the south side of Route 53
Source: Google

- Continue sidewalk network on both sides of Route 53 to provide access to bus stops and places of interest
- Consult with New Jersey Transit to provide access to bus stops along Route 53 and the potential for bus stop shelters
- Continue sidewalks level across business, not sloped with the driveway
- Repair broken, cracked, and sloped sidewalks
- Consider installing green infrastructure in areas that retain water

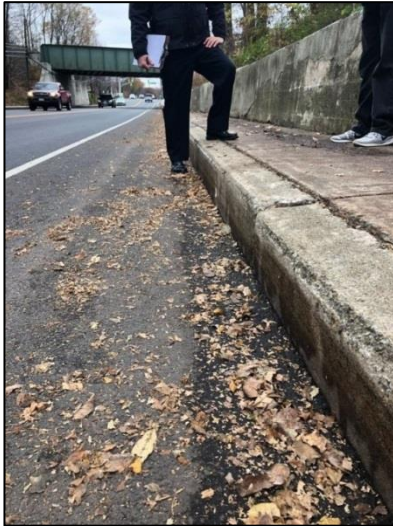
Extremely elevated sidewalk

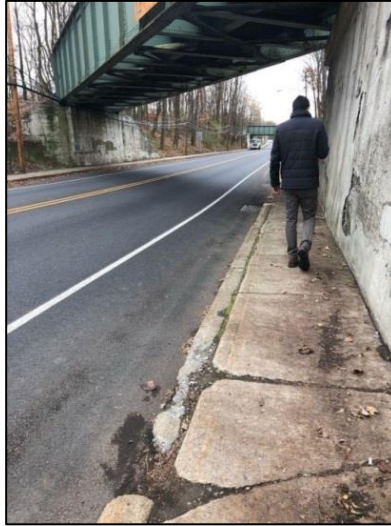
Narrow sidewalk

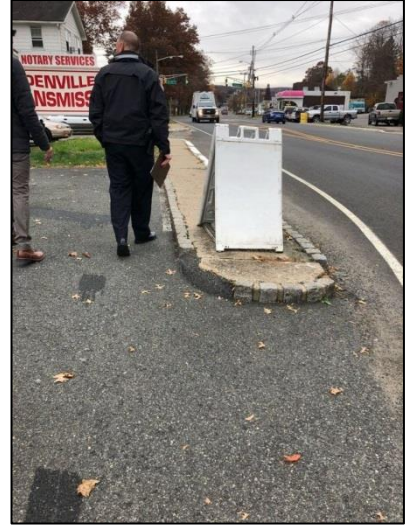
Sidewalk block and has ramp issues

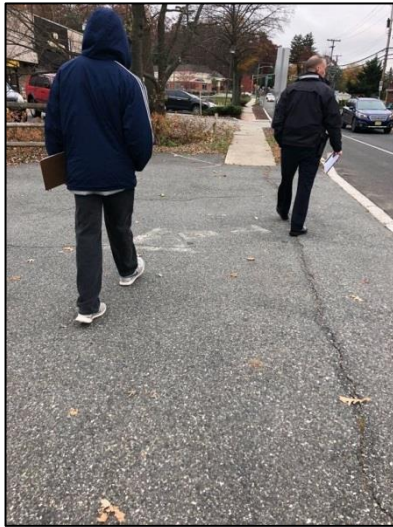
There are several businesses along Route 53 in Denville, however, the sidewalk does not continue across the business driveways, creating a location for cars and not for people. At many of these driveways, the area where sidewalk should be has an increased slope with the driveway and does not remain straight. Between Manor Road and Fox Hill Road, there lacks a continuous sidewalk network. Areas of sidewalk along the Morris County School of Technology were also observed to be sloped and covered by leaves and water.

Sidewalk does not continue across driveways

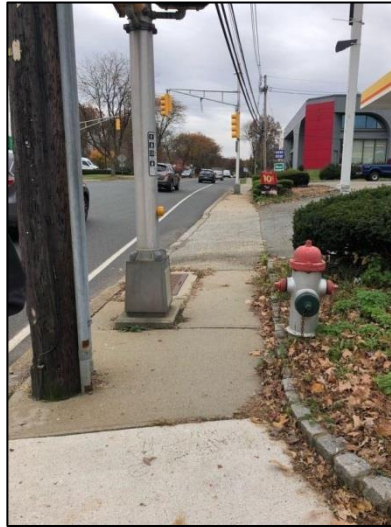
Sidewalk blocked by light and telephone pole

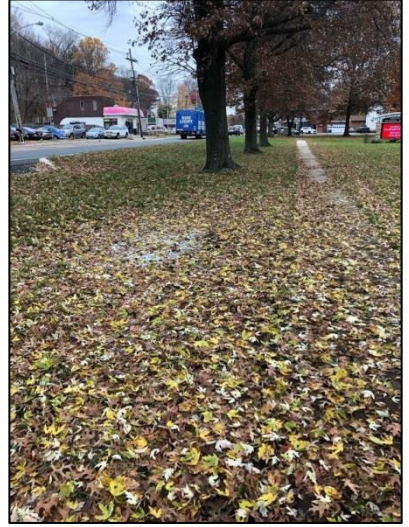
Vo-Tech sidewalk covered in leaves and water

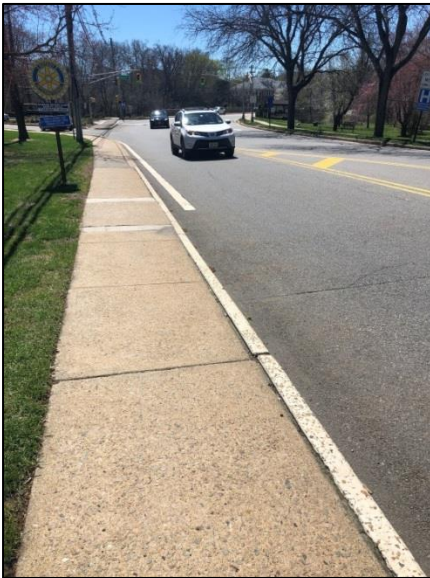
Short shoulder ends on Diamond Spring Road north after Pocono Road

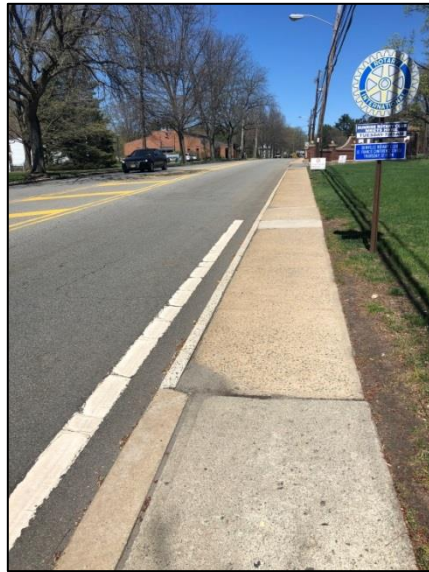
Short shoulder ends on Diamond Spring Road north after Pocono Road

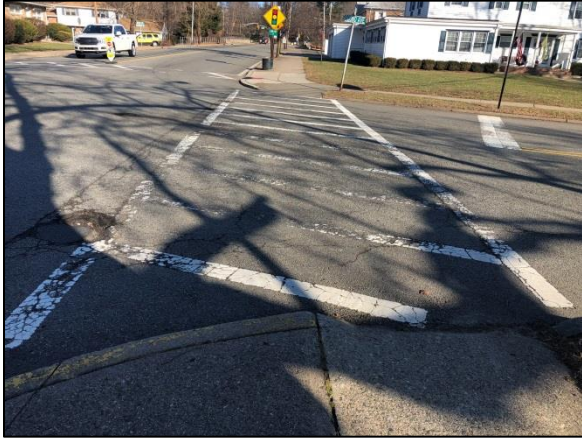
There is a lack of tactical warning strips/truncated domes at Second Avenue, Pocono Road, and River Road intersections. At the Second Avenue intersection, a red painted square on the curb apron provides a visible warning but is lacking any tactile warning. Additionally, at many intersections crossing paint is faded and low visibility.

Faded crosswalk at 2nd Avenue and no truncated dome/ADA compliance

- Re-stripe crosswalks to be consistent and high-visibility (see Appendix A for crosswalk recommendations)
- Install tactical warning strips/truncated domes at all crossings
- Consider pedestrian crossing signage to alert drivers of crosswalk at the intersection of Pocono Road and Diamond Spring Road
- Signage to alert cars of crossing at Pocono road should be considered as well as more visibility at crossing to alert drivers of crossing. Examples of this are pedestrian crossing sign, delineated crosswalk, turning vehicles yield to pedestrians
- Make sure curb ramps do not have an extreme slope for ADA compliance

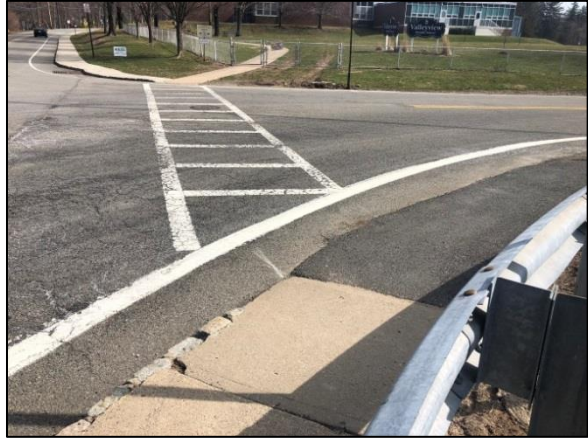
Lack of ADA infrastructure at the middle school

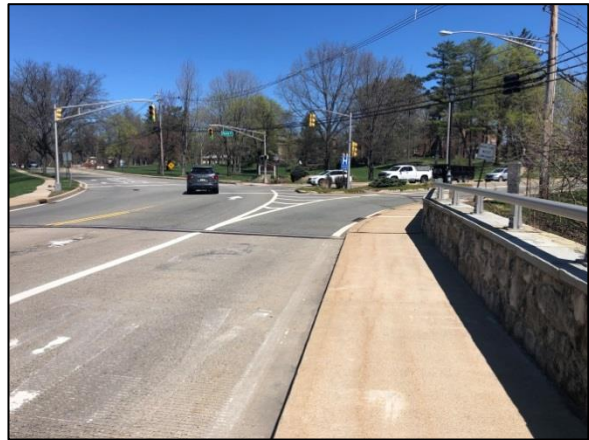
Pocono Road intersection crossing is hard to see

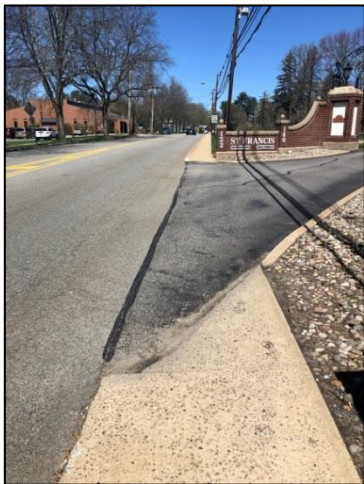
Sidewalk does not continue across driveway at St. Francis

- Repair sidewalks and curbs that are broken or cracked
- Continue sidewalks across business driveways to create a pedestrian zone
- Maintain trees and shrubs to be clear of the sidewalk
- Evaluate the slope of the sidewalk especially across driveways
- Follow the 2017 Complete Streets Guide for sidewalk materials

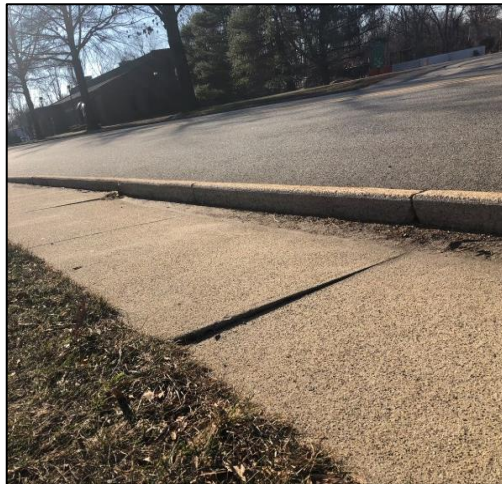
Sidewalk is sunken down and curb is raised along Diamond Spring Road

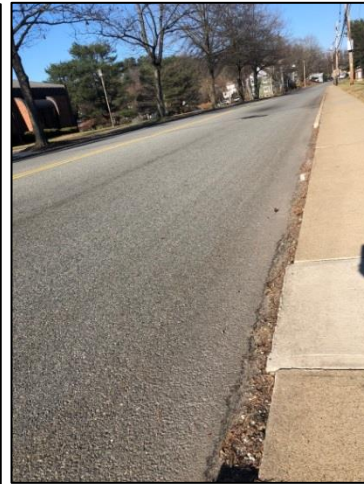
Curbing is crumbling, missing, damaged in sections after Pocono Road intersection

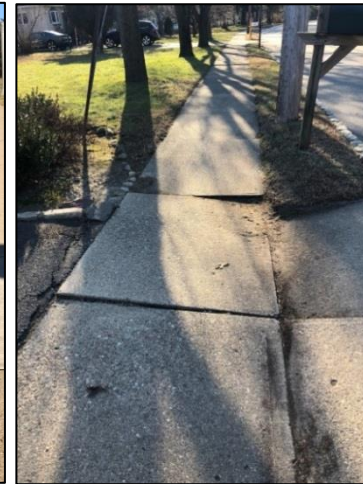
Cracked and uplifted sidewalk
